Yake effects in various telescope mirrors

K. G. Gupta *Uttar Pradesh State Observatory, Manora Peak, Naini Tal 263 129*

Abstract. The yake effect in the 56 cm and the 38 cm pyrex mirrors of the Uttar Pradesh State Observatory is described. Similar effects elsewhere are also discussed.

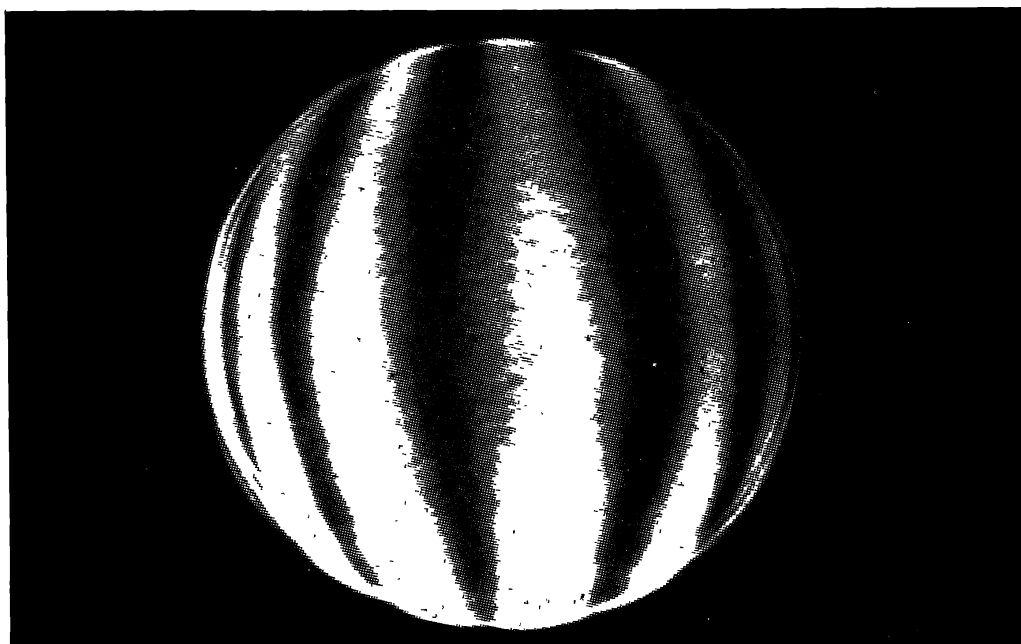
Figure 3. Ronchigram of the 56 cm zerodur replacement mirror.

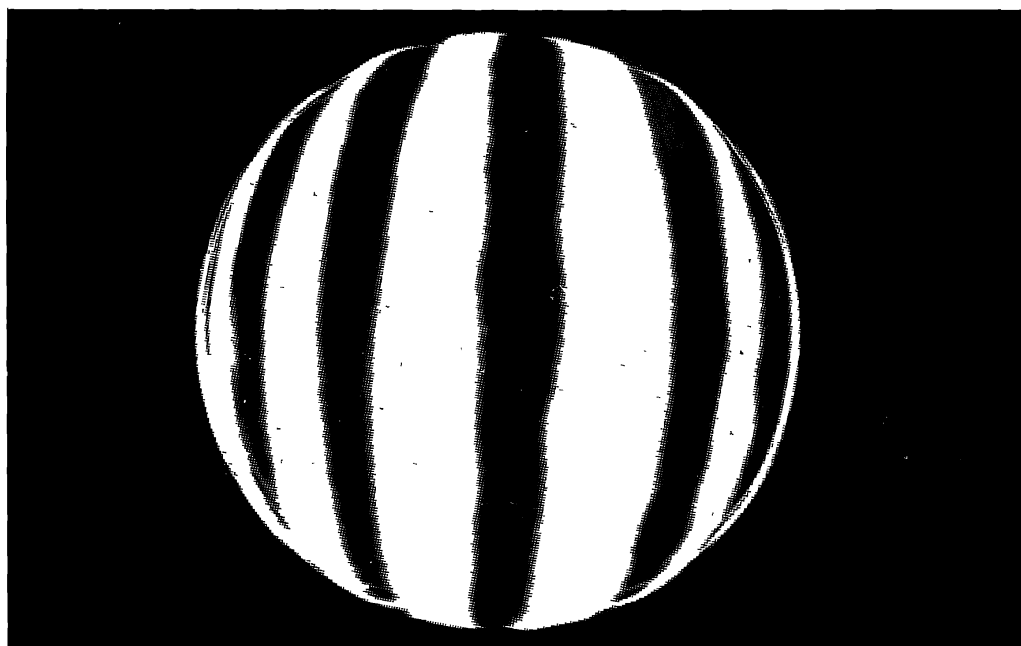
**Figure 2.** Ronchigram of the 56 cm pyrex mirror after refiguring.
